REPORT

Knickerbocker Pool & Aquatic Equipment/ Systems Improvement Analysis and Recommendations

Troy, NY

May 19, 2017

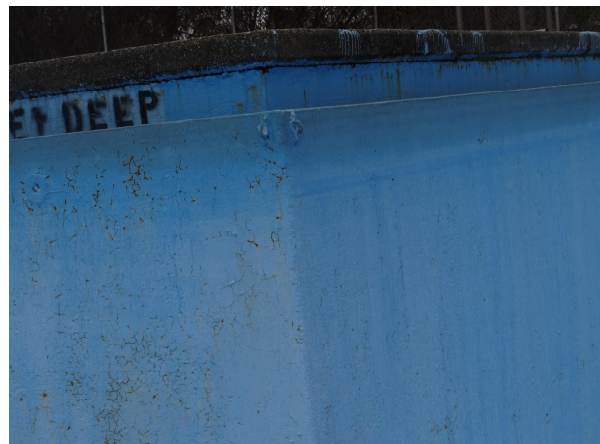
One of the key elements that we noted during our investigation for update is the pool's existing finish. The pool's existing finish is a painted top coat. It has lasted well but is showing signs of degradation. Areas throughout the pool are spalling and separating from the steel base. Being the pool shell is steel, it is critical that a durable finish be applied and integral to avoid further deterioration of the shell. The *Pool Finish Upgrade* has several options available to select from. To assist you, we have created a [Pool Finish Comparison Narrative](#) (see Appendix A) which lists six finish options with general pros and cons to each. To further assist, we have also created a [Pool Liners- Pros and Cons](#) summary worksheet (included in Appendix A) which is based on the key factors. Work within this section shall include at minimum 1) protection of all existing pool equipment (eg: step area, grab rails, gutter, etc.), 2) preparation of existing pool's surface for proper application/adhesion of the new pool finish, and 3) application of the finish selected. This scope of work will include working around of all of the wall and floor penetrations (as necessary) such as the main drains, wall returns, etc. Depending on the surface selected, work may require removal of existing painted finish via sandblasting. The pool must be free of leaks after the finish is completed and warranty should cover workmanship.

DIF #1: Highly Recommended

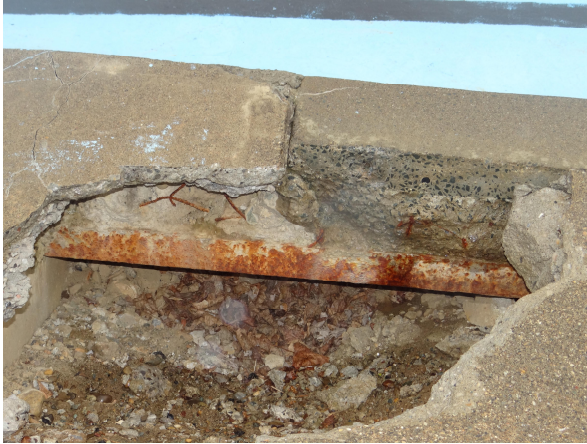
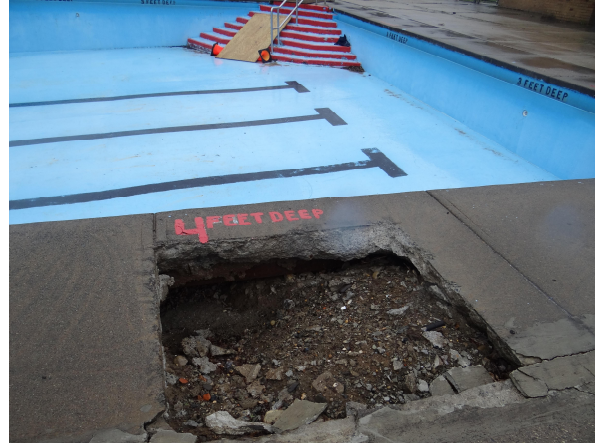
Several areas around the pool deck are clearly in need of repairs.

Chunks of concrete were removed from the pool deck. Several large cracks were observed and spalling is occurring at some locations. At minimum, portions of the deck needs repairs and/or full replacement in order to open this site.

DIF #1: Highly Recommended

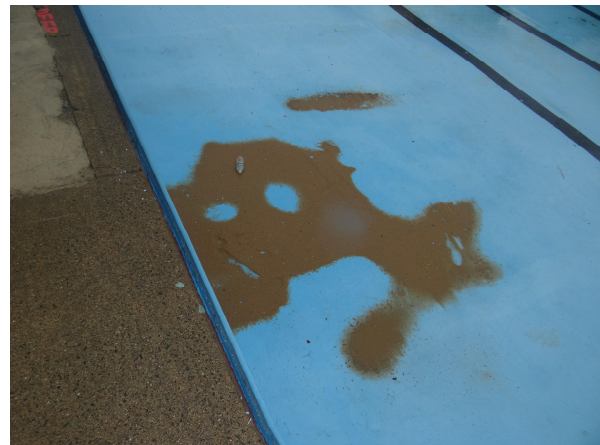
One of the standout Health code violations found at the existing pool has to do with the pool supply inlets and piping. It is clear that the pool's supply piping has been compromised as evidence from the amount of sand fines found within the pool. This occurs when the buried pool piping has been damaged to the point where the pipe sub-base fill is being extracted through the pipe and dumped into the pool. This not only suggests that the pool piping is no longer fully functional but the under deck may be undermined. The only solution to this problematic condition is to locate the damaged pipe and make the necessary repairs. We have estimated a few spots but without proper scoping, this is simply a best guess as to the existing damage.

DIF #1: Highly Recommended

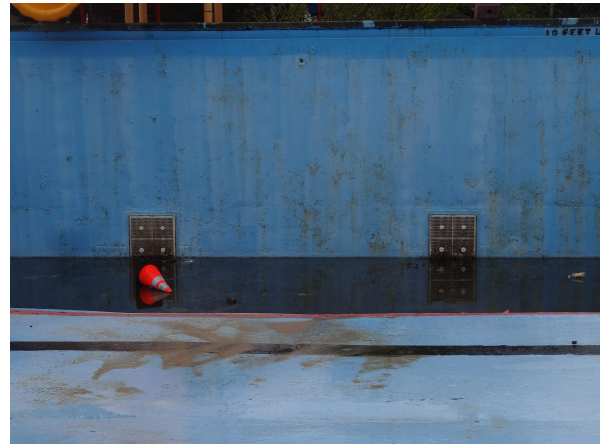
A total of two *main drains* were found during our facility walkthrough. No issues found as they have been located and sized to accommodate the pool. Aquastar VGBA compliant grates were installed on the drains.

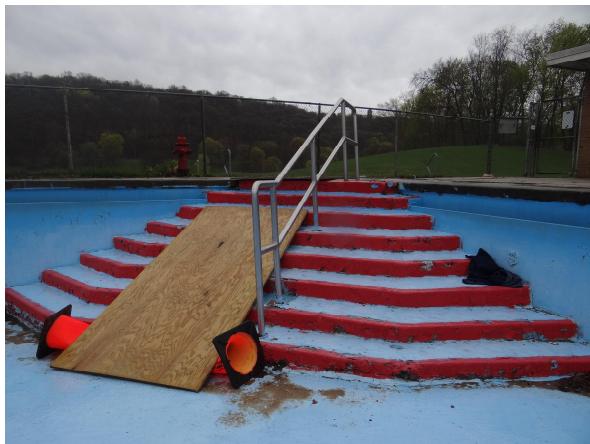
The existing pool's *Gutter* appeared to be in fair condition as there were some signs of age degradation. It does provide continuous skimming throughout the pool's perimeter with the exception of the stair area (gutter is not found throughout the steps).

This is technically not compliant with New York State swimming pool code and should be addressed. However, it is important to mention that the gutter's main purpose is for controlling wave surge or splash of which your gutter appears to have done the job. It is not supposed to function as the main return to the pump for circulation. This pool however does just this as it does not function using a surge tank. At minimum, the gutter should be corrected to comply with NYS Health code.

DIF #1: Highly Recommended

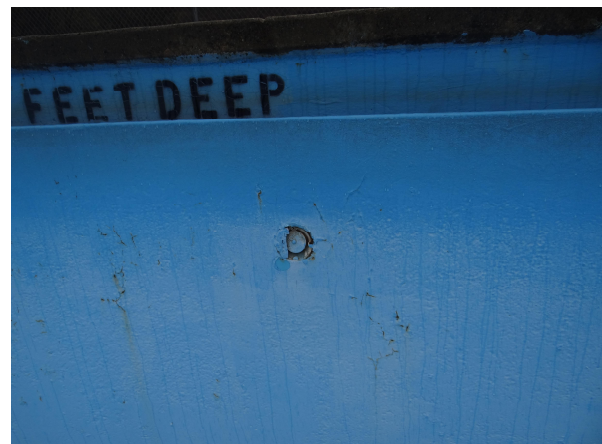
We did however notice degradation around some of the returns which indicates that the returns themselves may be corroding and not functioning adequately. It was difficult to tell what the returns were made of but if they are original to the original pool construction, it may be time to initiate

replacement with similar non-corrosive returns. For this reason, we have given this a higher priority.

DIF #1: Highly Recommended

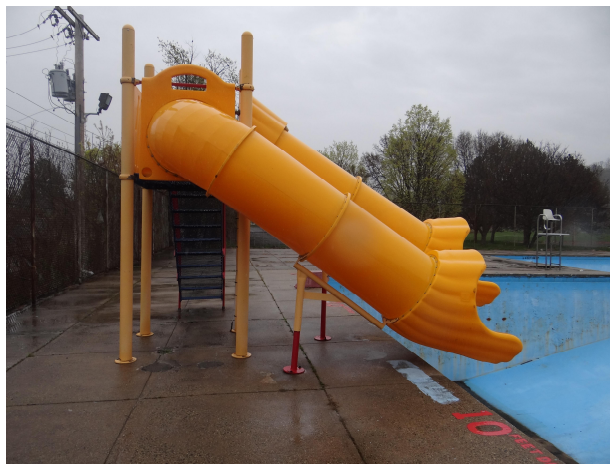
An approximate 12 foot high permanently installed double flume waterslide is located at the deep end of the pool. The slide is most likely a popular attraction to the facility's patrons. The slide structure is made of steel which is painted. The slides flumes are an enclosed tube style and are plastic. The slide's steps and upper platform is a perforated metal material and are showing signs of corrosion and deterioration. In general, the slides are in fair condition. The metal steps, platform and framework however are in poor condition as the steel members are showing signs of corrosion which should be abated and/or replaced.

DIF #2: Somewhat Important

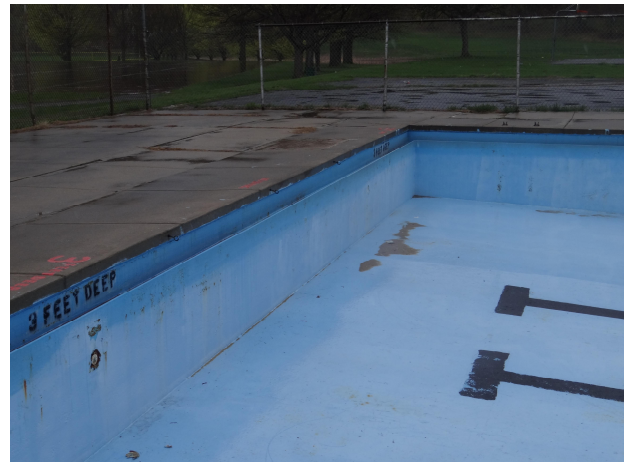
The facility's existing depth markers are positioned both on the pool deck and around the pool's gutter face perimeter. The depth markers are all painted and are of a contrasting color to visually indicate location water depth. The depth markers do in fact comply with NY State Swimming pool code.

However, the paint is beginning to wear and should be considered for being touched up.

DIF #3: Suggested

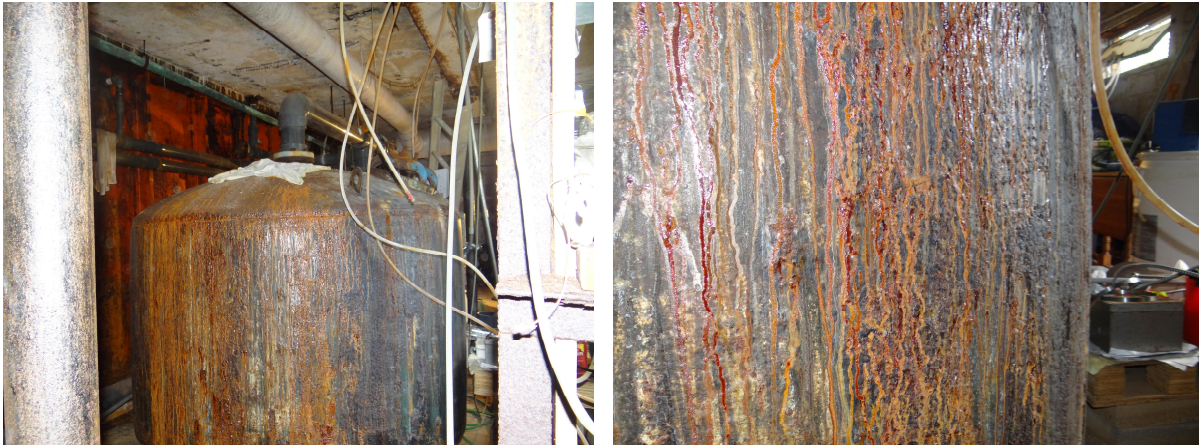
The existing *filtration system* is a single tank steel vertical high rate sand filter manufactured by Neptune Benson which is showing severe sign of corrosion. It without a doubt should be replaced. High Rate Sand is one of the more common methods of swimming pool filtration and is a reliable and low maintenance option. Although the nameplate is difficult to read with rust staining present, we believe the filter is

original to the pool's construction which would place it at or around 40 years old. Fiberglass filtration systems have been around for a number of years and have proven to be both resist to the demands of corrosion while still maintaining the structural integrity of the pressure (and vacuum) conditions experienced. We would therefore recommend that a fiberglass High Rate Sand filtration system with automatic controls be installed.

DIF #1: Highly Recommended

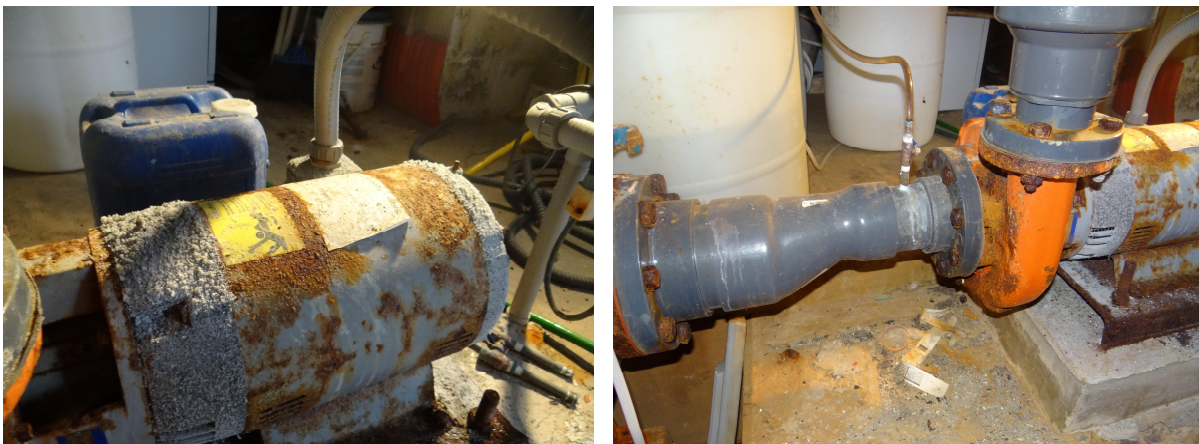
The *recirculation pump* is the heart of the recirculation system. As per Department of Health swimming pool code, it must run 24/7. The existing recirculation pump is a flooded suction type and has reached the end of its typical life expectancy. It must be replaced. We would also recommend a second pump be added for two reasons: 1) to create a backup in case one of the pump motors goes down and 2) to be able to alternate between the pumps to evenly distribute the normal wear. The pumps must be NSF listed as this is a prerequisite according to State Sanitary Code. We also recommend that all wetted parts of the pumps be epoxy coated to help avoid interior surface corrosion. We recommend two Aurora pumps (HP TBD) be installed (with isolation valving) in the same location as the existing pump.

DIF #1: Highly Recommended

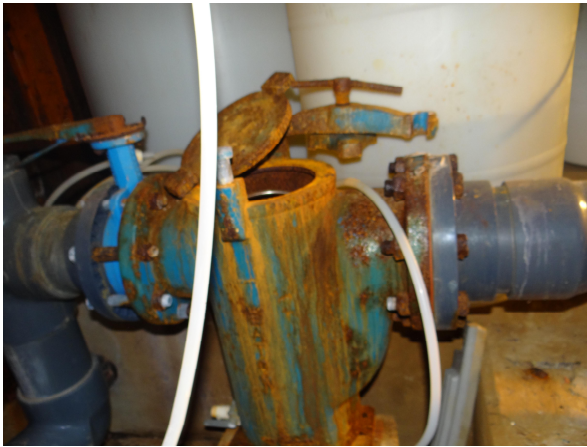
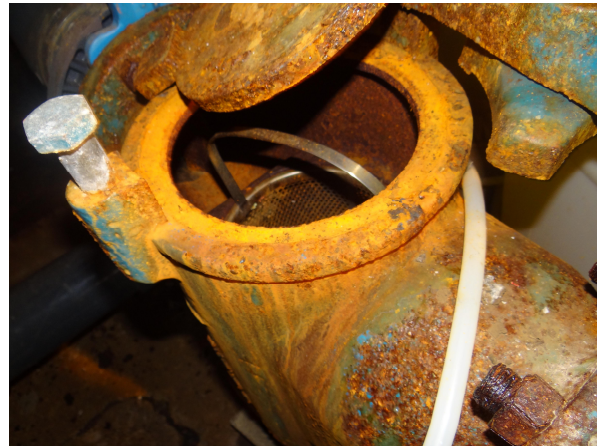
The *strainer* is meant to trap large particles from entering and damaging the recirculation pump. The existing strainer is manufactured out of steel and has been susceptible to corrosion. It is showing signs of age and significant staining. We recommend a non-corrosive FO eccentric style fiberglass strainer as manufactured by Fluidtrol be installed in place of the existing. Additionally, a spare stainless steel strainer basket will be required per NY State Health Dept. code.

DIF #1: Highly Recommended

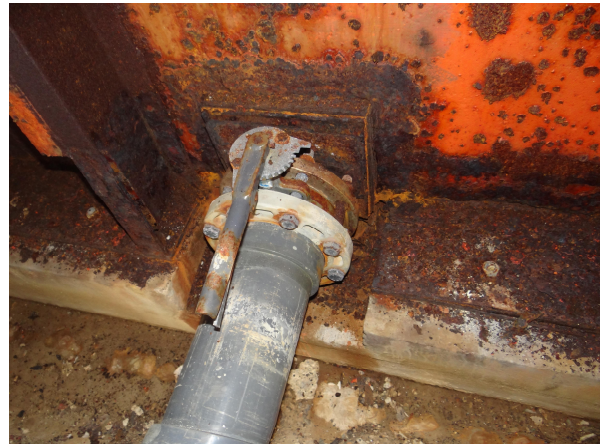
The existing pool piping has been replaced over time with schedule 80 PVC which was a good observation. However, some of the butterfly valves are either non-functional or nearing the end of their life. Valves are in need of replacement particularly around the chemical injection lines which were corroded. This recommendation is intended to include the materials and installation of new valves that require replacement.

DIF #1: Highly Recommended

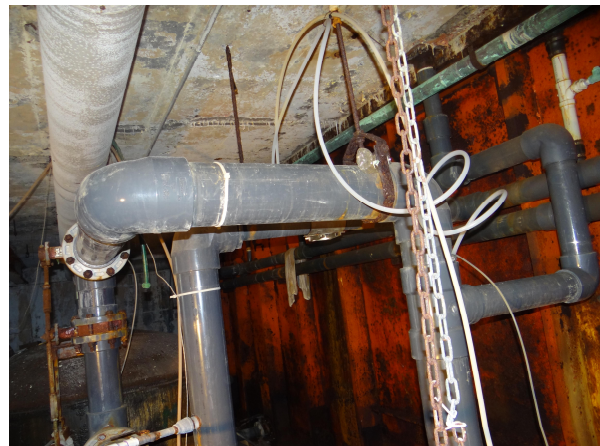
During our site inspection of the mechanical equipment, the absence of a check valve after the pump discharge was noted, as well as the absence of an isolation valve. A check valve on the discharge side of the circulating pump is typically considered a necessity. A check valve that will eliminate backflow where the system is installed below grade is also very desirable and is typically installed after the pump discharge. Similarly, a butterfly valve will provide isolation necessary for when the pump needs to be taken out of service. This recommendation includes the materials and installation of these two types of valves.

DIF #3: Suggested

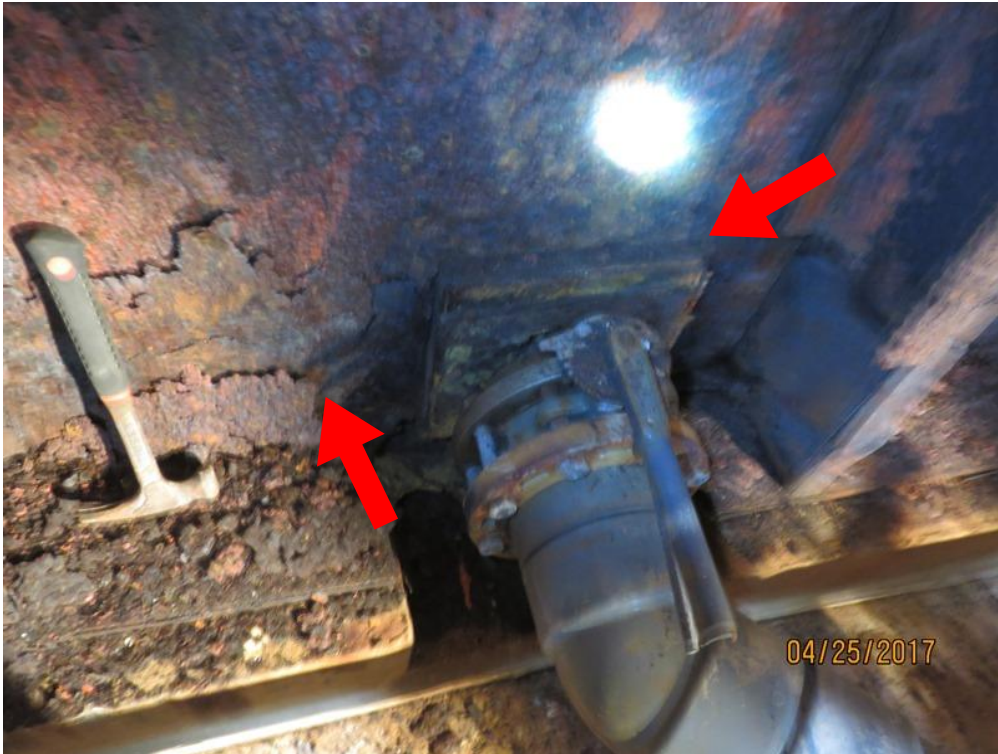
- a) We observed corrosion on the pool walls caused by water leaking through damaged welded connections between the pool wall and pool floor. At this location, there is also a corroded pipe

penetration caused by a damaged joint seal and water is leaking through the damaged joint. Similar conditions occur at other locations (*See Appendix B, Photograph Nos 4 and 8*).

<p>04/25/2017</p>
LOCATION: Filter room – Exterior of pool wall	
DESCRIPTION: Corroded pool wall and pipe penetration connection. Up to 30% section loss.

1. Address all ADA & state swimming pool health code violations.
2. Upgrade all failing and/or failed equipment that is beyond repair (i.e.: filter system, recirculation pump, strainer, chemical systems, valves, piping and supports, etc.).
3. The severely corroded portion of the pool wall with section loss should be immediately repaired and reinforced.
4. The exposed pool wall in the filter room needs a protective coating.
5. The corroded reinforced channels and the angles behind the pool wall in the filter room should be replaced.
6. The welded connection joints between the pool floor and the pool wall should be repaired.
7. The unexposed part of the pool wall should be further examined.
8. All pipe penetration joints should be replaced.

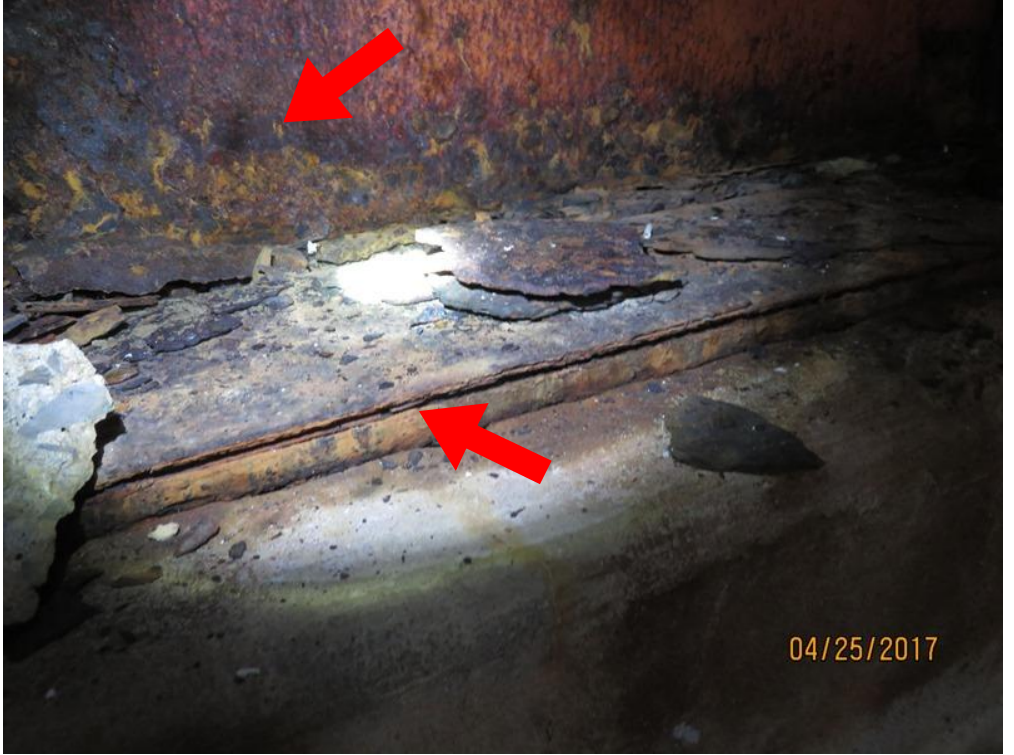
PHOTO No: 5	
LOCATION: Filter room – Pool wall

- b) We observed pitting of base plates caused by water leaking between pool wall and pool floor at several locations (*See Appendix B, Photograph No 5*).

DESCRIPTION: Pitting of base plate between steel channels.	
PHOTO No: 6	
LOCATION: Filter room – Pool wall at crawl space

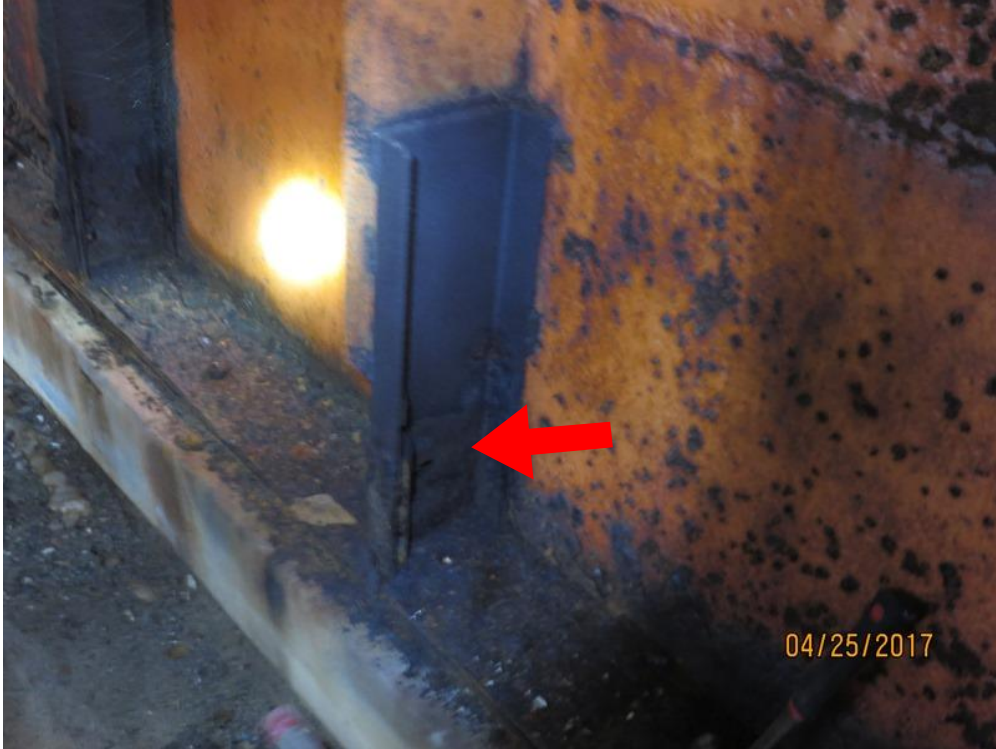
PHOTO No: 7

- c) We observed corroded channels and angles in several locations, up to 100% section loss caused by water leakage between pool wall and pool floor. (*See Appendix B, Photograph Nos 6, 7 and 9*).

LOCATION: Filter room – pool wall	
DESCRIPTION: Corroded channel. Up to 100% section loss.	
PHOTO No: 8

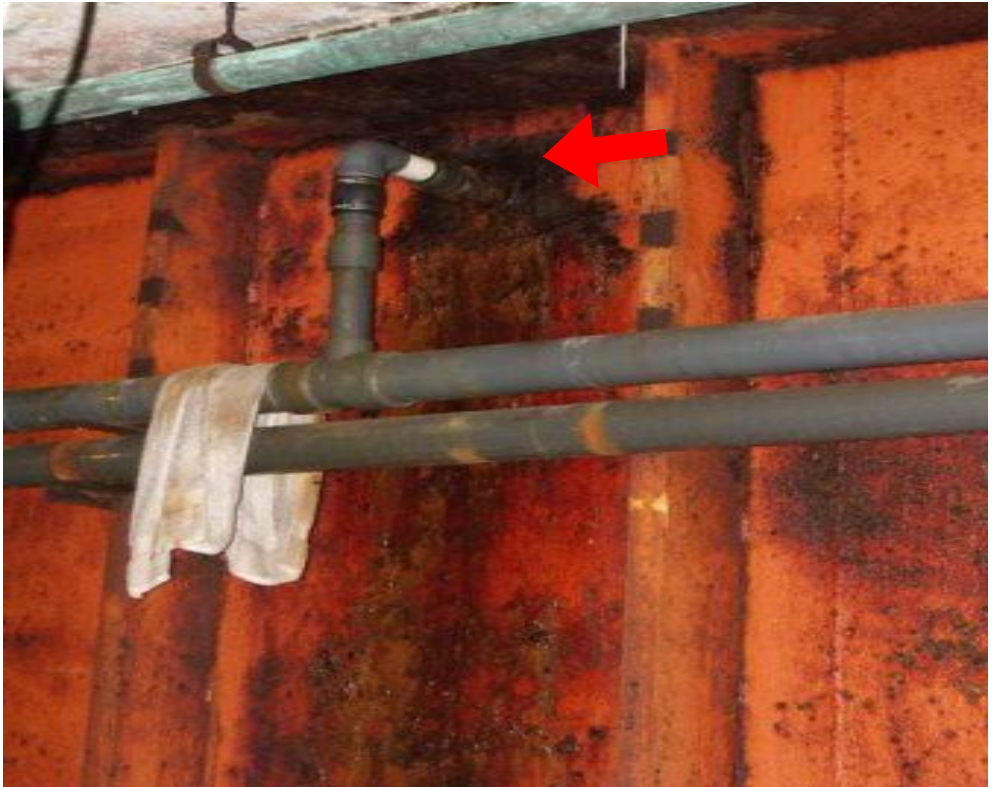
LOCATION: Filter room – Pool wall	
DESCRIPTION: Severe corroded pool wall at the pipe penetration and damaged joint seal material.

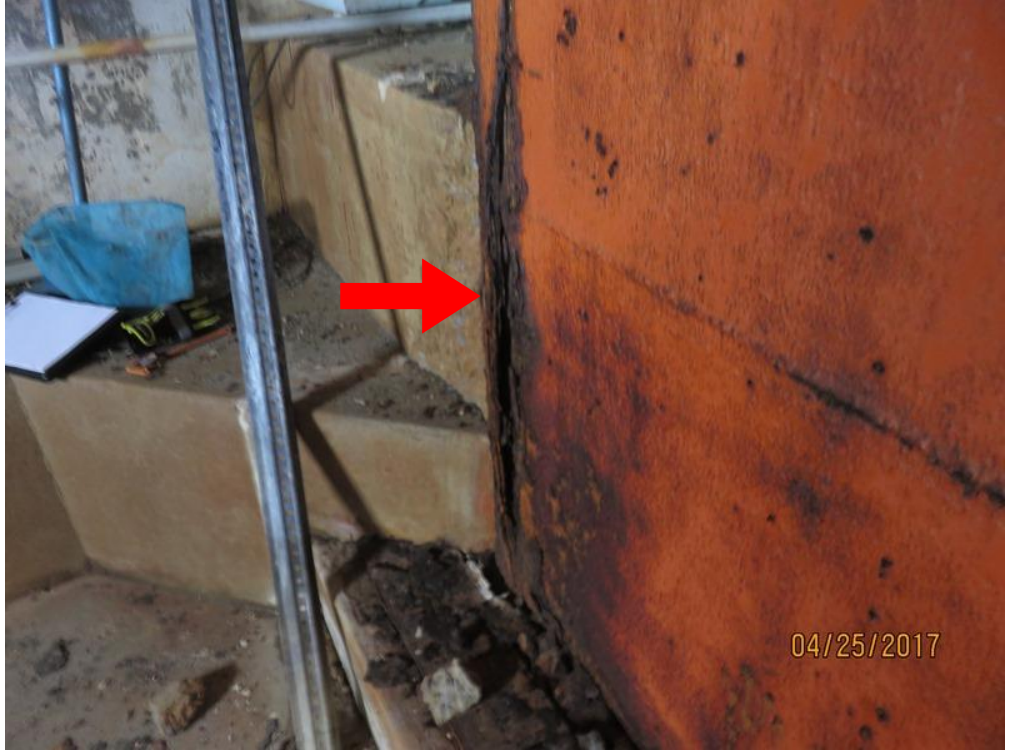
PHOTO No: 9	
LOCATION: Filter Room – Pool Wall	
DESCRIPTION: Corroded angle at the corner of the pool wall. Up to 80% section loss.

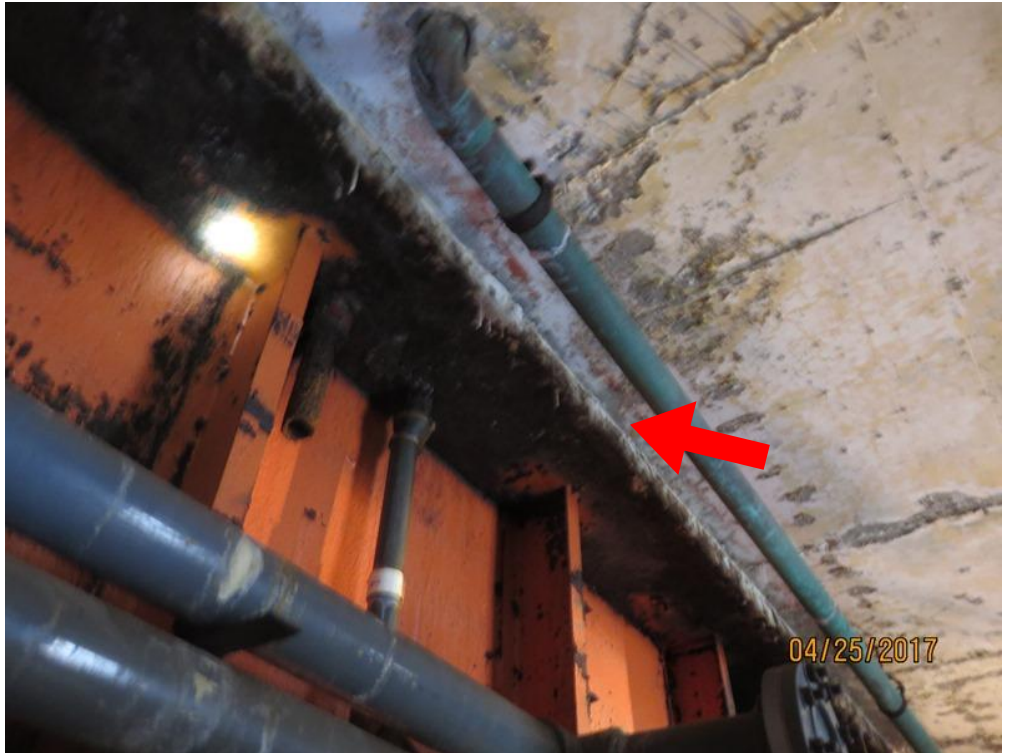
- d) At several location along the pool walls, CHA observed corrosion on the built-up beam caused by water infiltrating through joints in the precast concrete deck and cracks in the reinforced concrete roof deck (*See Appendix B, Photograph No 10*).

PHOTO No: 10	
LOCATION: Filter Room – Pool wall	
DESCRIPTION: Corroded built-up beam below the concrete roof deck and behind the pool wall.

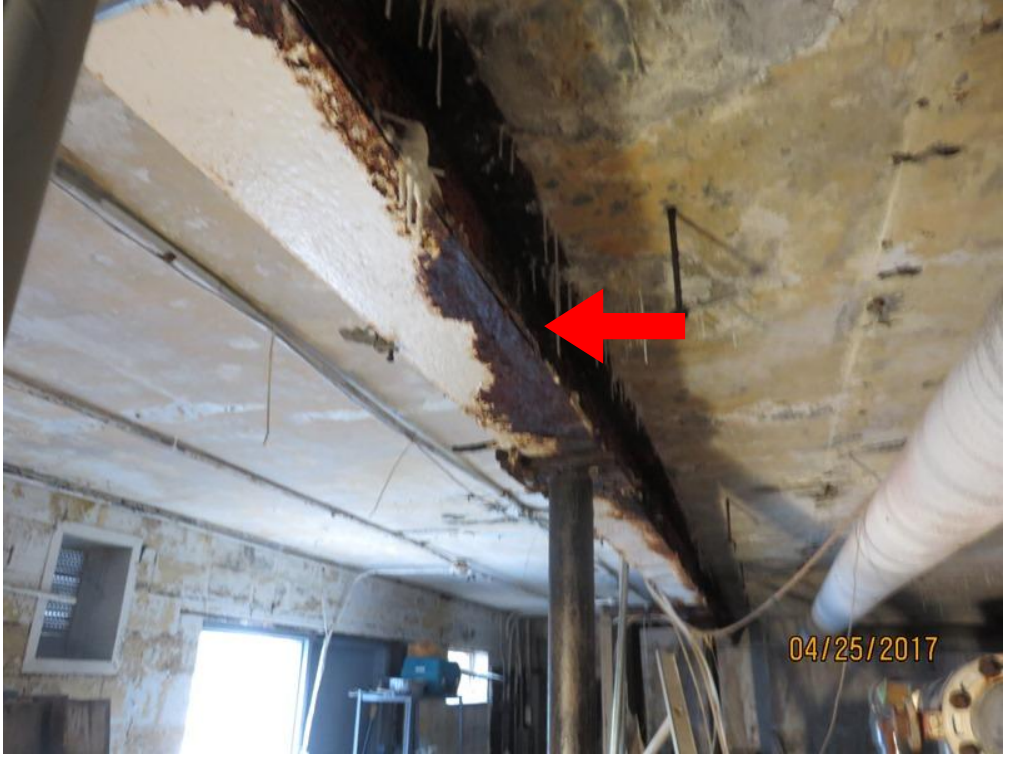
PHOTO No:11

- e) We observed a severely corroded wide flange beam which provides support to concrete roof deck. A plausible cause for the corrosion is from water leaking through the joints in the precast concrete deck and cracks in the reinforced concrete roof deck (*See Appendix B, Photograph No 11*).

LOCATION: Filter room – Concrete roof deck	
DESCRIPTION: Corroded wide flange beam under the concrete roof deck. Up to 10% section loss.	
PHOTO No: 12

9. The wide flange beam located at the underside of concrete roof deck in the filter room should be replaced.
10. All cracks and spalls on the underside of concrete roof deck should be repaired with an epoxy injection sealant.
11. Joints between the precast concrete deck panels should be sealed.
12. Replace the pool deck panels requiring replacement.
13. All spalls, openings and cracks in or on the precast concrete deck panels should be repaired.
14. An appropriate HVAC system should be added to the pool equipment room to abate the severe corrosion occurring in any renovation scenario.
15. A drainage system should be provided around the amenities building.
16. All cracks and spalls associated with the amenities building should be repaired.

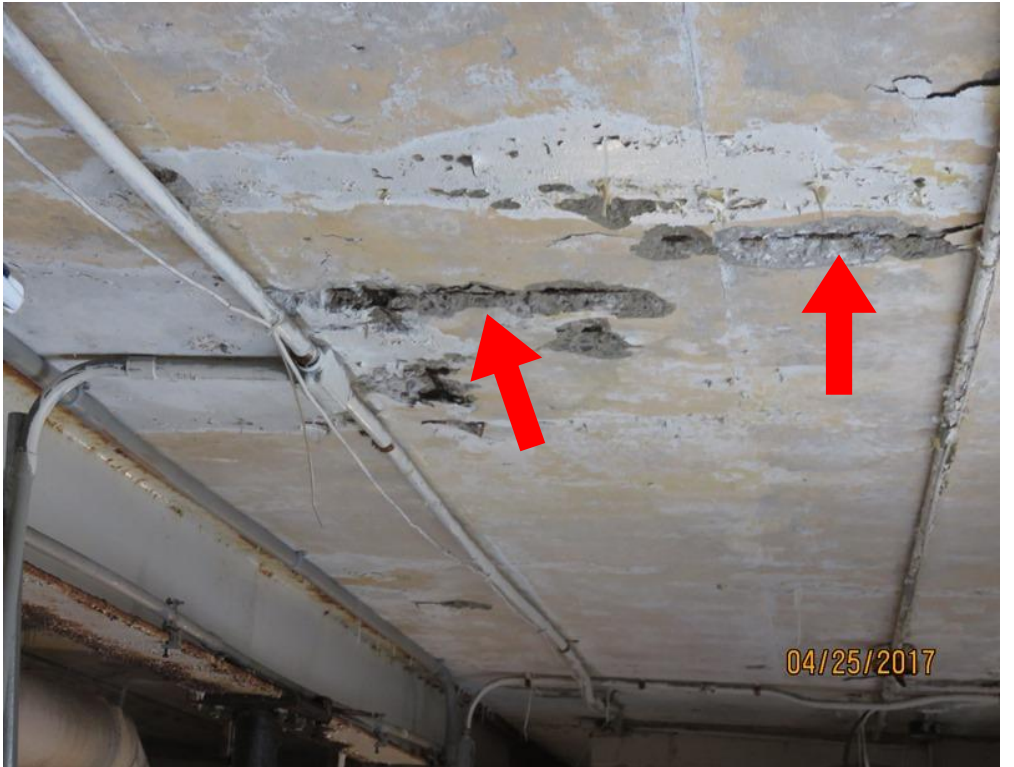
- f) We observed large concrete spalls and wide cracks with exposed reinforcement at the underside of the reinforced concrete roof deck. Water is leaking through cracks and joints of precast concrete deck panels and concrete roof deck. The water is corroding the reinforcement steel in the concrete causing the steel to expand and spall the concrete cover. This occurs at several locations along the underside of the concrete deck (*See Appendix B, Photograph Nos 12 13, 14, and 15*).

LOCATION: Filter room – Concrete roof deck	
DESCRIPTION: Large concrete spalls with exposed reinforcement at the underside of concrete roof deck.

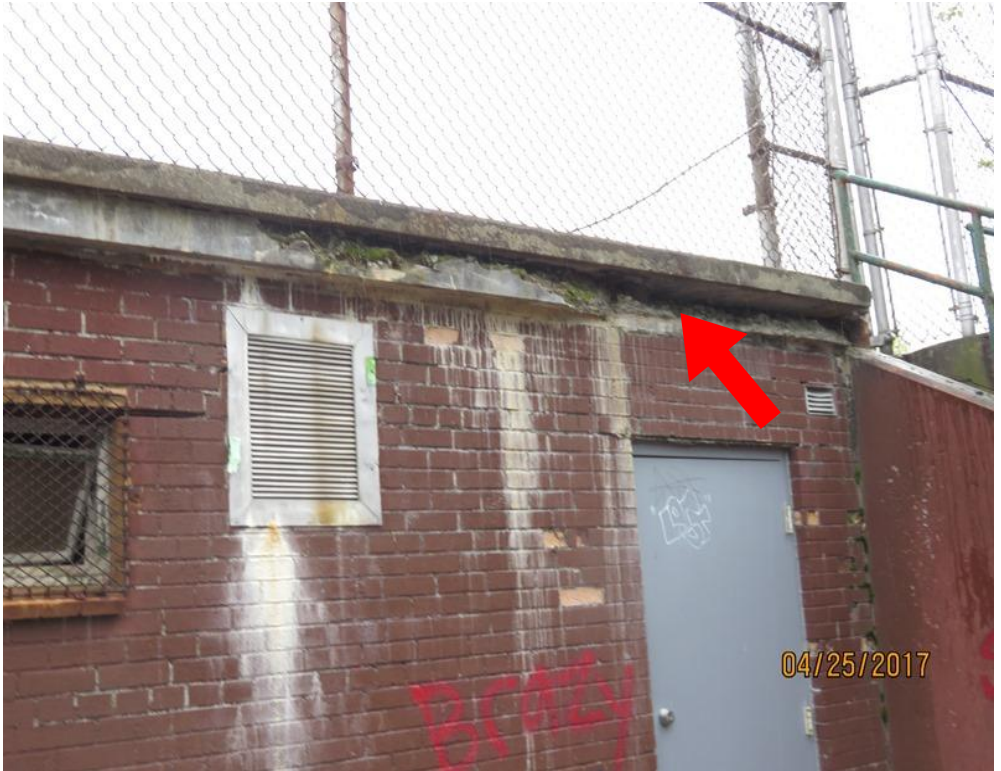
LOCATION: Filter building – Exterior wall and roof overhang	
DESCRIPTION: Large concrete spall on roof deck.

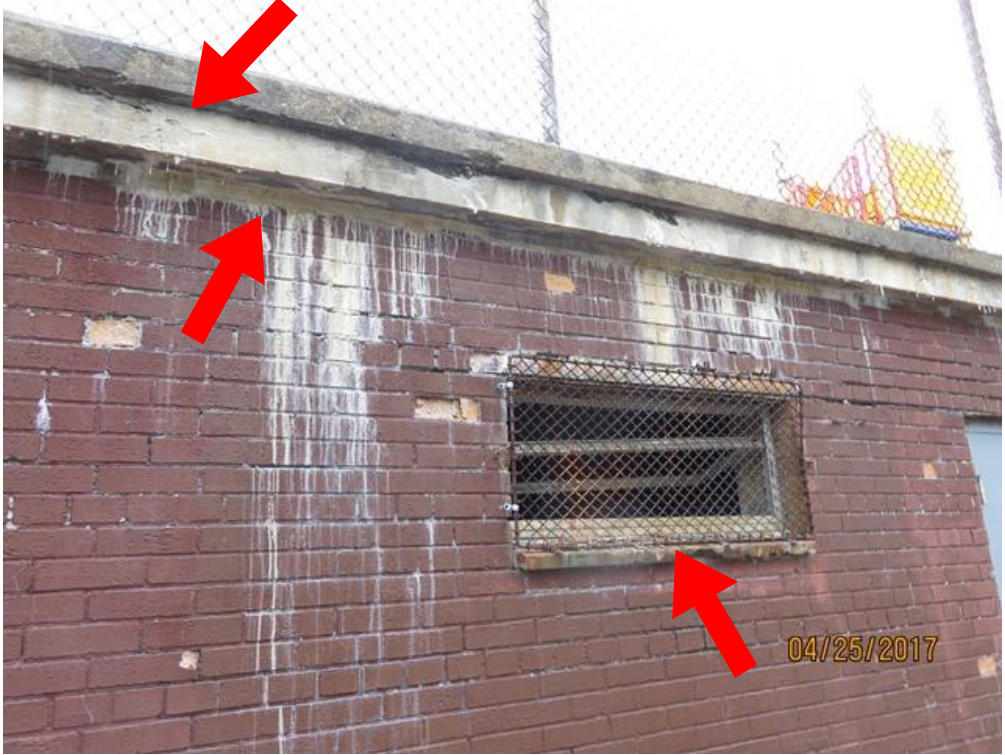
PHOTO No: 15

<p>04/25/2017</p>
LOCATION: Filter building – Exterior wall and roof overhang	
DESCRIPTION: Wide cracks in concrete roof deck with efflorescence. Deteriorated window and window covering.	
PHOTO No: 16

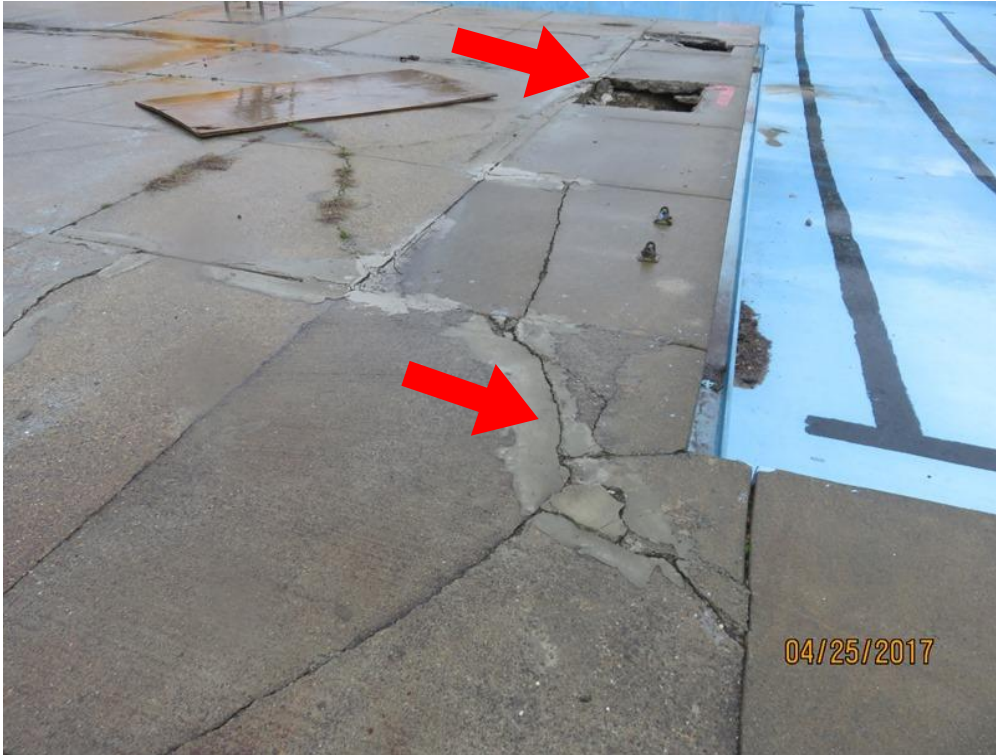
- g) We observed wide cracks in the precast concrete deck caused by unequal settlement of the base support and a large opening in deck. Water is leaking through joints and the openings (*See Appendix B, Photograph No 16*).

<p>04/25/2017</p>
LOCATION: Pool site - Deck	
DESCRIPTION: Wide cracks and large opening in concrete deck.
